Long Duration Exposure Facility

Systems Special Investigation Group

Interim Report

January 1991

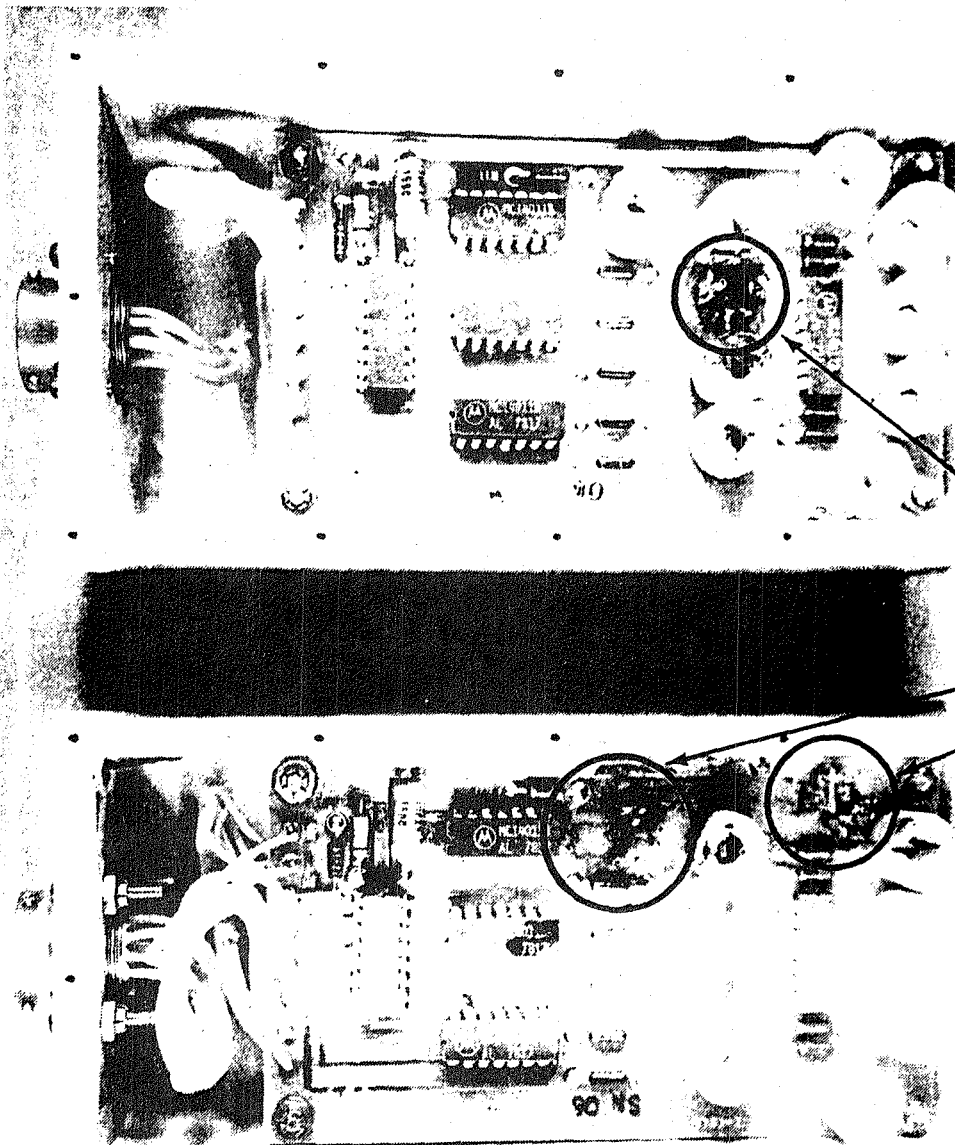
PHOTOGRAPH OF THE EFFECTS OF E-CELL LEAKAGE

Four of the seven HVPS were mounted on the exterior surfaces of the experiment while the remaining three were mounted on interior (inside of LDEF) surfaces. All four exterior HVPS experienced at least one E-cell failure while the interior mounted HVPS possessed no failed E-cells. This leads us to believe that operating temperatures played an important role in the E-cell leakages.

The leakages did not seem to effect the overall performance of the individual HVPS, but further testing is required to confirm this.

E-cell sockets destroyed
by leaking E-cells

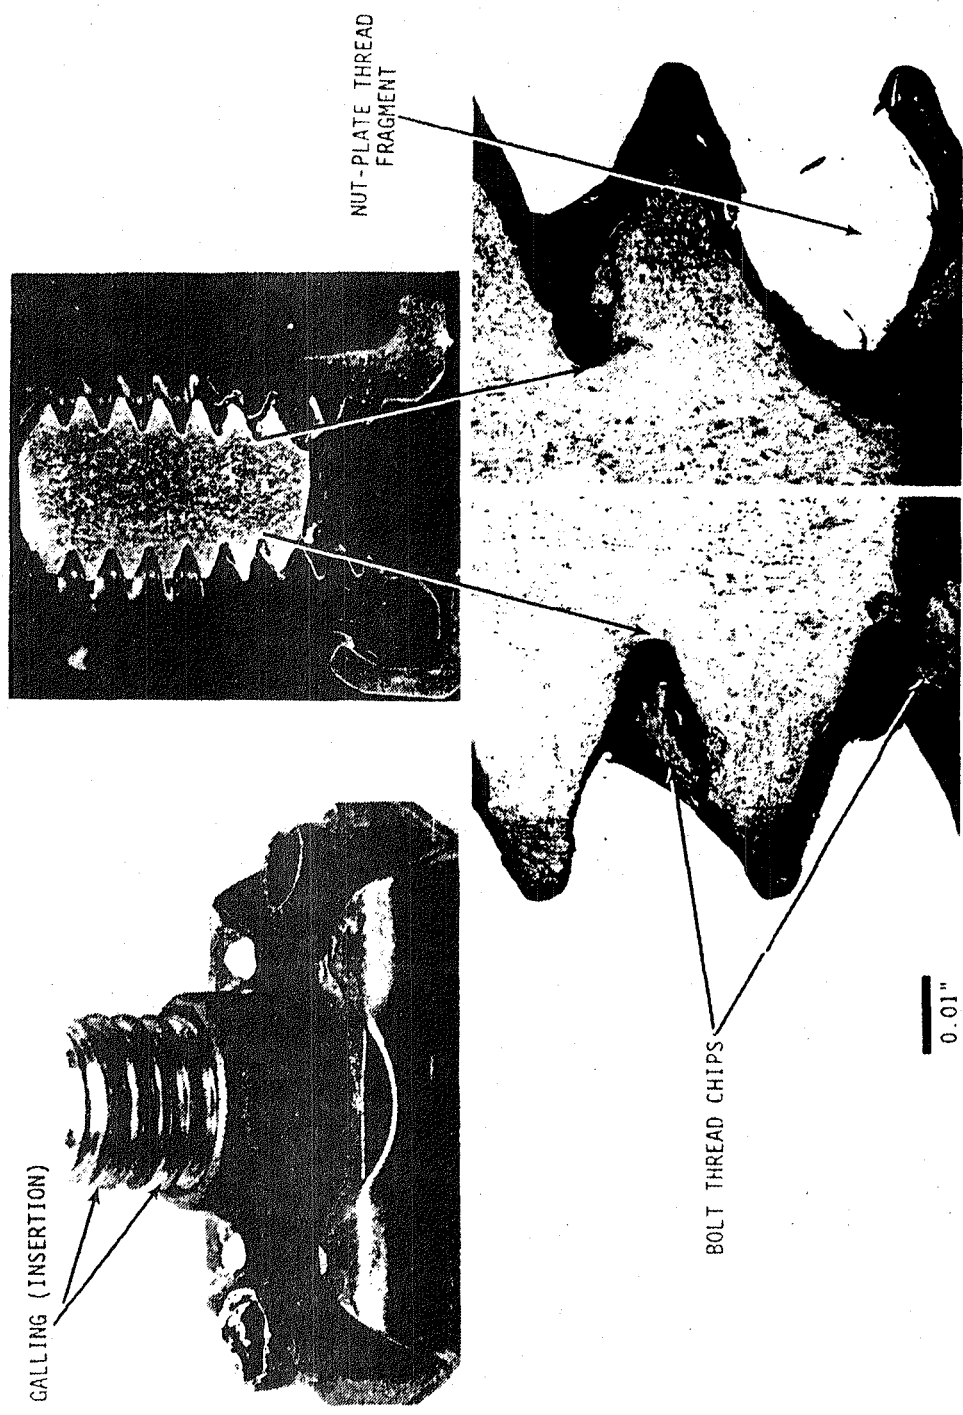
Fastener Sheared During Attempted Removal

Visual examination of a large number of stainless steel bolts indicated that the problems were most likely related to installation damage. Metallographic sectioning of seized bolts confirmed this explanation. As an example, the facing figure shows that in the case of one tray fastener, seizure and subsequent shearing was caused by galling damage induced during original installation. The galling damage was clearly visible on the exposed portions of the bolt threads. This galling is more pronounced than what would be caused by being cycled through the self locking feature contained within the nut plate. The original galling damage caused bolt thread chips and nut-plate fragments to be generated when removal was attempted. The chips then caused jamming of the threads. No evidence exists of cold-welding between the bolt and nut thread surfaces.

We have received three fastener assemblies from PI hardware possessing sheared bolts caused by attempted removal. Using the procedure described in the above paragraph, it has been determined that all three failures were the result of galling caused by pre-flight assembly and/or post-flight removal.

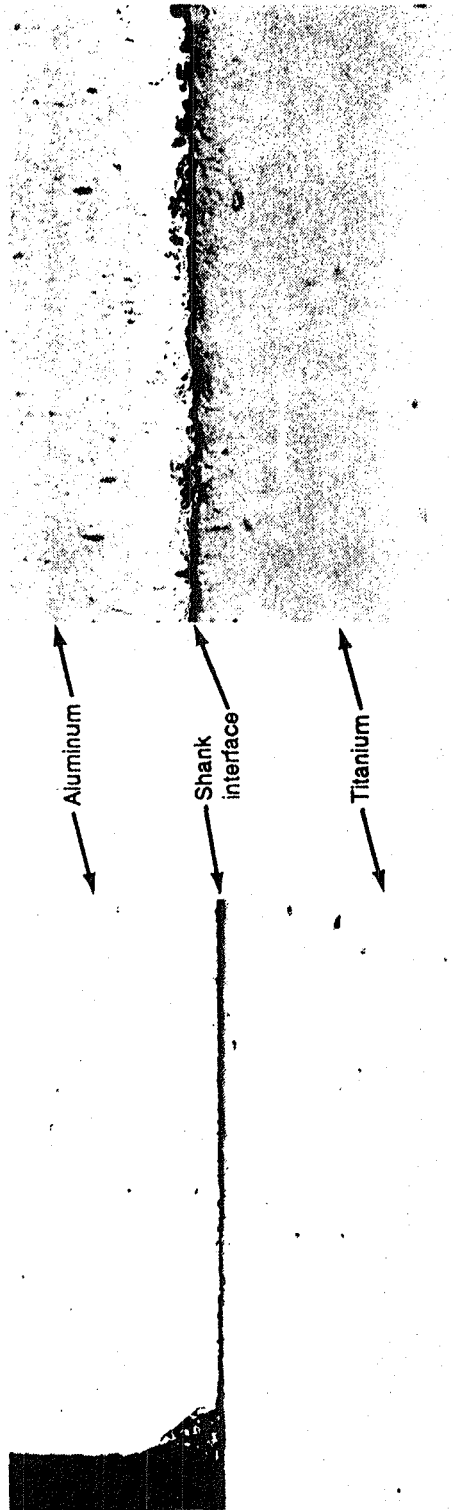
Intercostal Fastener Cross-section

Examination of the bolt shank interfaces (opposite page) reveals no evidence of cold-welding. The thread faying surfaces (following page) also show no evidence of cold-welding; however, minor galling and some smearing of the silver-plating (specified for lubrication) on the stainless steel nut is evident.

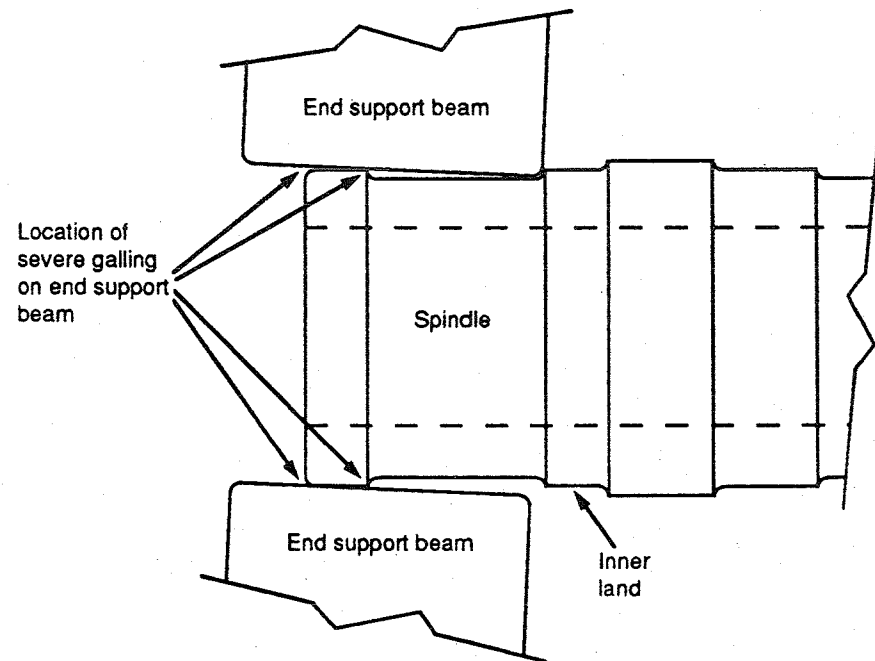
Position of End Support Beam When It Became Stuck on Spindle During Removal Attempt

During post-flight removal, no difficulties were encountered during the initial axial displacement of the ESB from the spindle. However, after approximately one inch of axial displacement had been accomplished, a great deal of difficulty was encountered.

Review of the video documenting the removal of the ESB strongly indicated these difficulties and the resulting galling damage to the aluminum ESB bore were caused by alignment difficulties. The hoist installed to support the beam apparently caused it to cock and jam on the spindle as the beam was pulled off of the first spindle land. Uncontrolled and excessive rotation of the jammed ESB about the spindle in an attempt to further move it caused extensive galling damage on the inner bore of the ESB as seen in the following photograph.

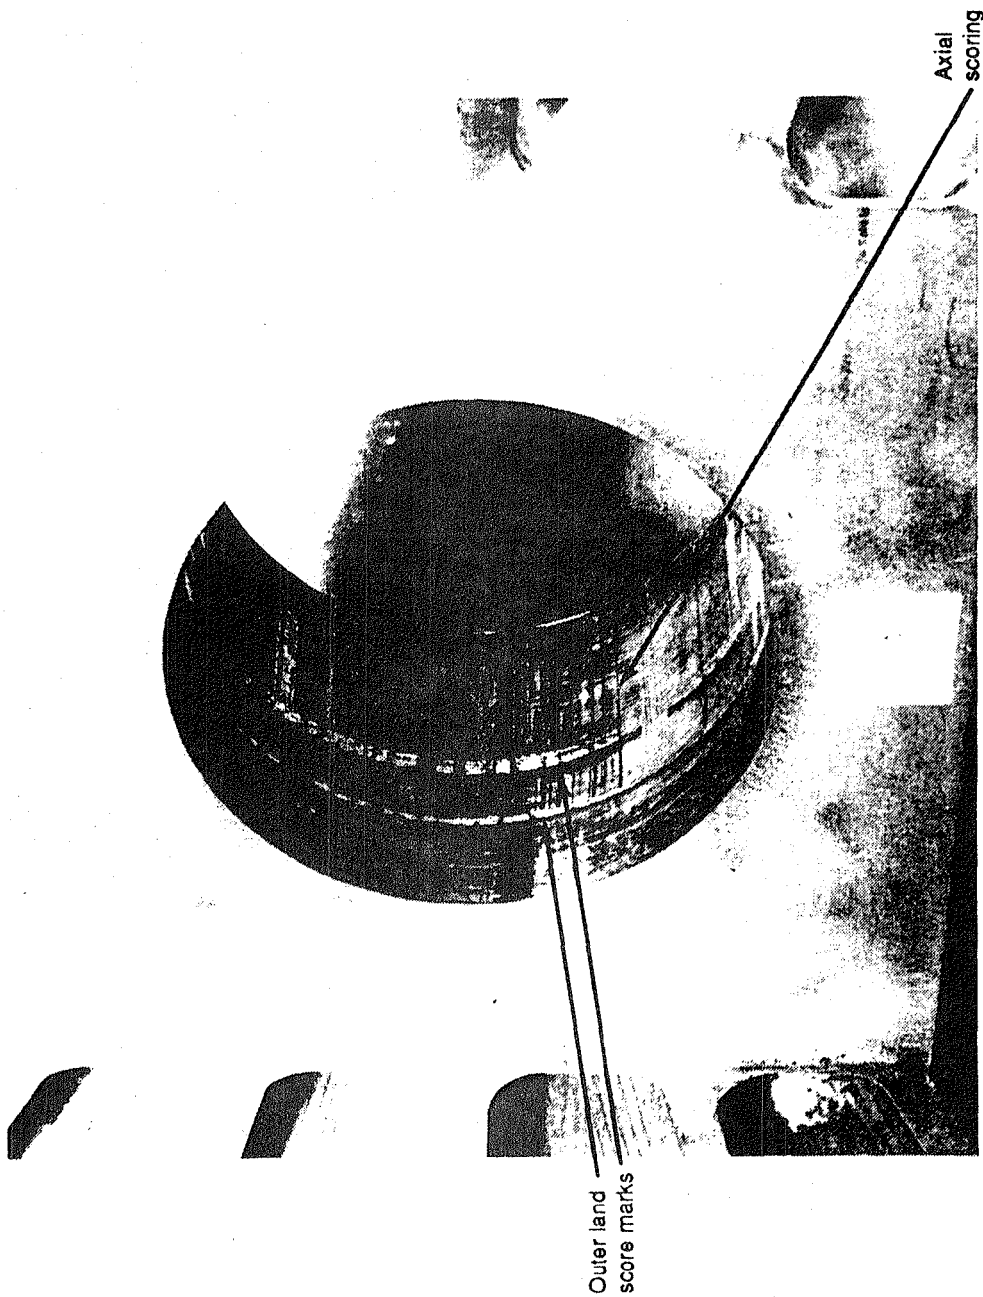
Front Surface of ESB
End Support Beam

Severe galling and scoring is apparent in the bore of the ESB. The two circumferential score marks nearest the front face of the ESB correspond to the position and width of outer land of the spindle when the beam jammed after coming off the inner spindle land. Uncontrolled rotation of the ESB about the spindle during further removal attempts caused galling between the stainless steel spindle and aluminum ESB which resulted in scoring of the softer aluminum. The axial scoring in the bore was caused when a gear-puller was finally employed to remove the beam.

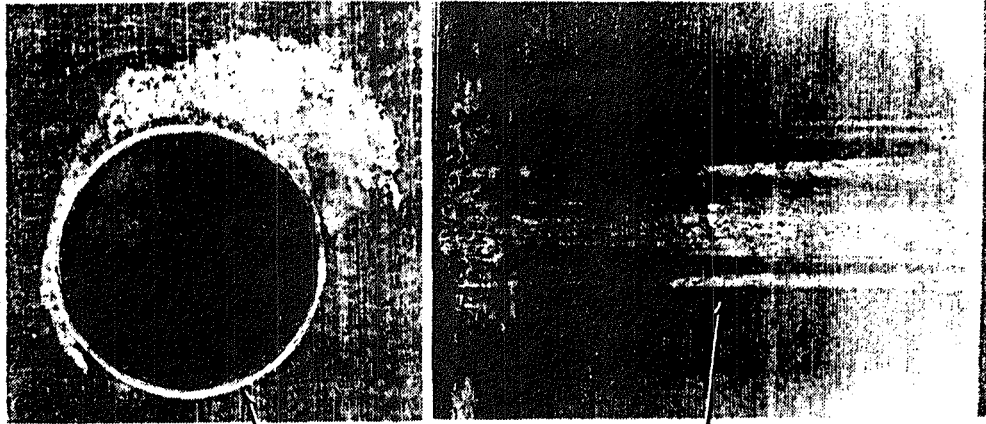
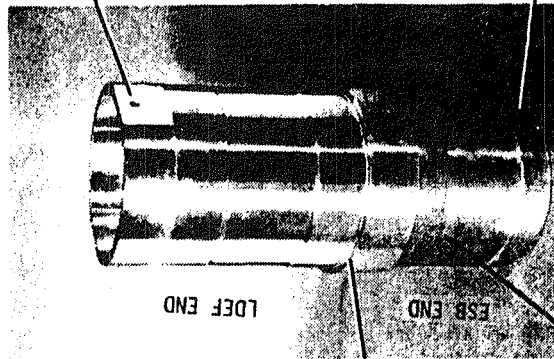
Galling and
aluminum
transfer

The lower right hand photograph shows galling damage/aluminum adhesion on the outer land of the stainless steel spindle. Aluminum was transferred to the edges of the land during rotation of the ESB. Subsequent gear-puller removal caused the axial streaks. Evidence of minor fretting damage was observed on the portion of the spindle inserted into the LDEF structure as indicated in the center photograph. Small relative motions between the LDEF structure and the spindle caused during transport and flight are the probable source of the fretting.

Metal transfer
associated with
galling

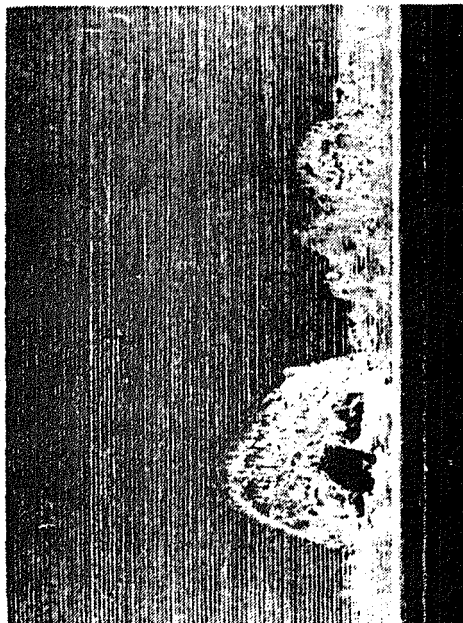
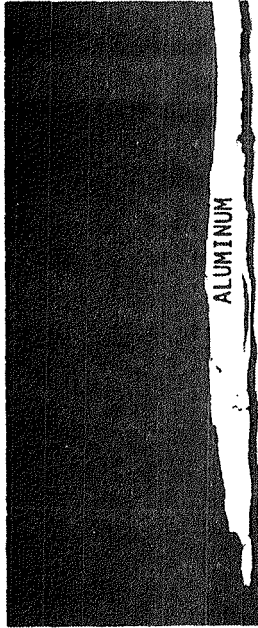
GALLING AND
ALUMINUM ADHESION

To confirm that the galling of the ESB bore and aluminum metal transfer to the outer spindle land was caused by removal damage and not cold-welding during flight, metallographic cross-sections were prepared. Shear deformations of the microstructure of aluminum stuck to the spindle land are consistent with removal motions. No evidence of cold-welding between the aluminum and the stainless steel spindle was observed.

The photograph on the right is a cross-section of the area shown on the left. As can be seen, there is no metal diffusion between the aluminum and stainless steel. The discrete interface between the aluminum and SS indicates that cold-welding did not occur.

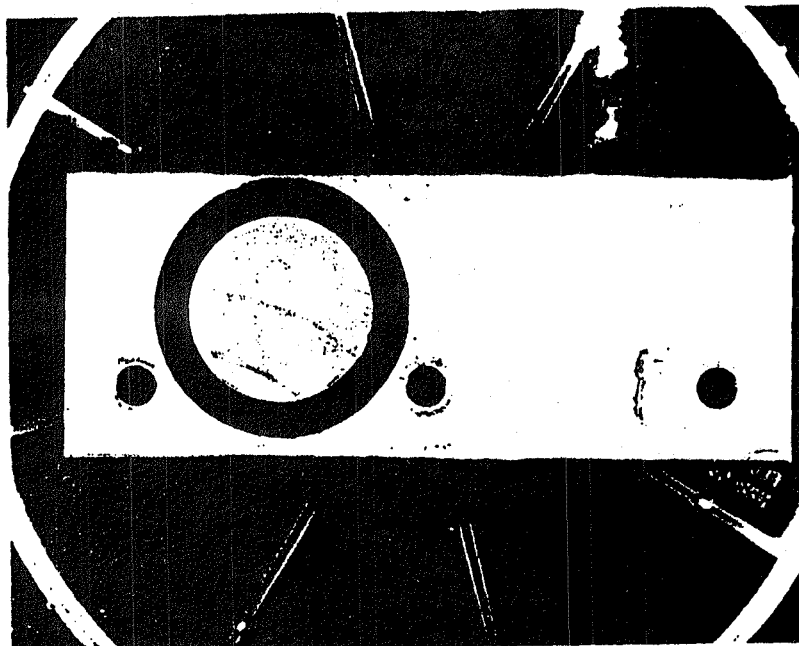
Figure 5 contains photographs of the clamp from tray E-02-6. The areas on the clamp which were protected by the shim and the ground strap can be easily detected as lighter regions on the clamp surface. Obviously, contamination from external sources has contributed some of the discoloration on the exposed area. The role of UV and atomic oxygen exposure in this discoloration is being investigated.

FIGURE 5. Photo macrographs of tray clamp E02-6 with arrows indicating boundaries between exposed regions and those protected by (A) the copper ground strap and (B) the aluminum shim.

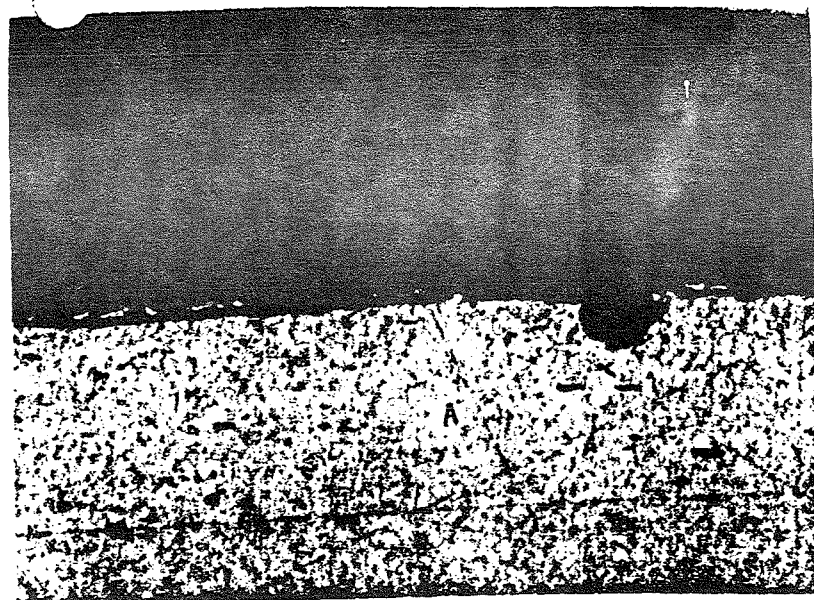
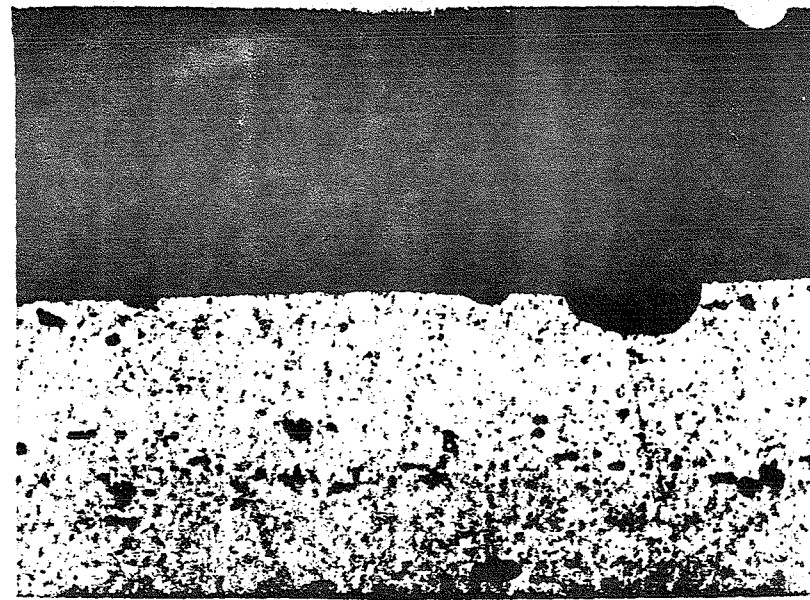
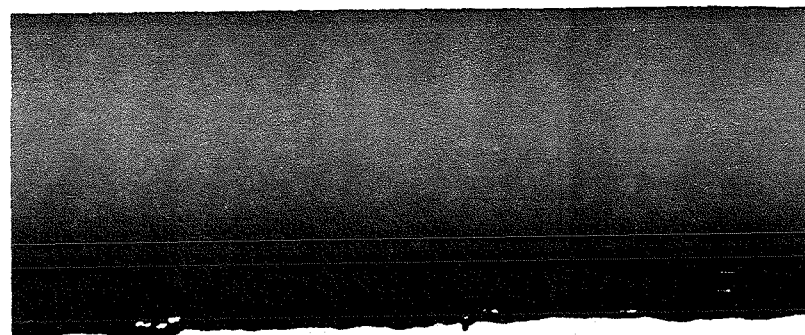
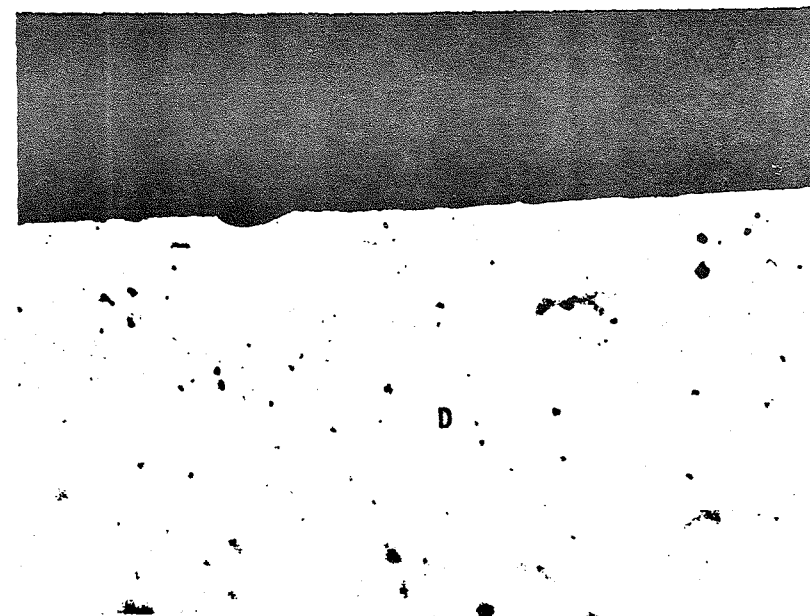
Figure 6 contains photomicrographs of cross sections obtained from exposed and protected areas of tray clamps subjected to leading edge exposure (Figure 6 A&B from clamp E10-6) and trailing edge exposure (Figure 6 C&D from clamp E02-6). The most notable feature in these figures is what appears to be debris on the protected surfaces of the clamps.

FIGURE 6. Optical photomicrographs at 1000X depicting (A) protected and (B) exposed regions from the surface of leading edge clamp E10-6 and from (C) protected and (D) exposed areas from trailing edge clamp E02-6.

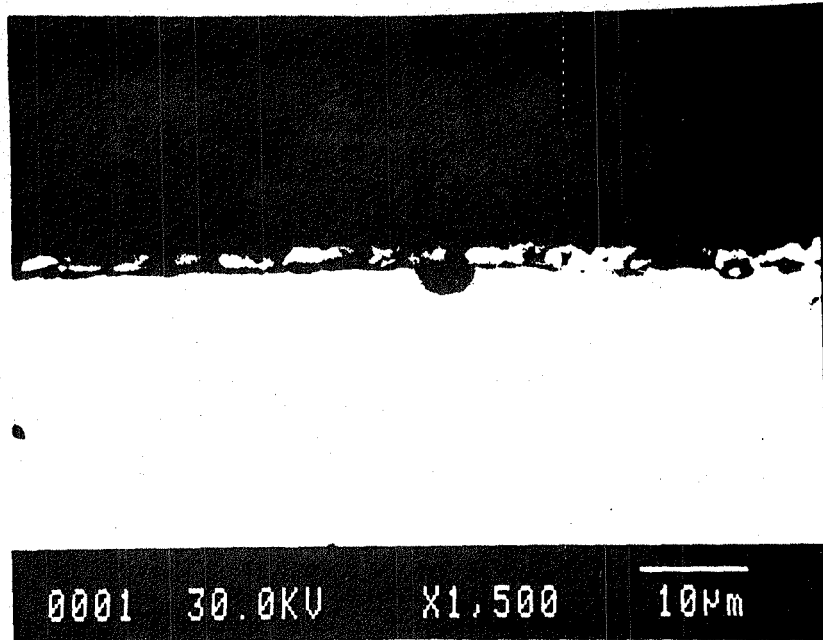
SEM Photomicrographs revealed that what appeared to be isolated pieces of debris was actually a discrete layer on the surface of the clamp.

FIGURE 7. Higher magnification scanning electron photomicrographs depicting the observed surface layer on the protected surfaces of tray clamp E10-6.

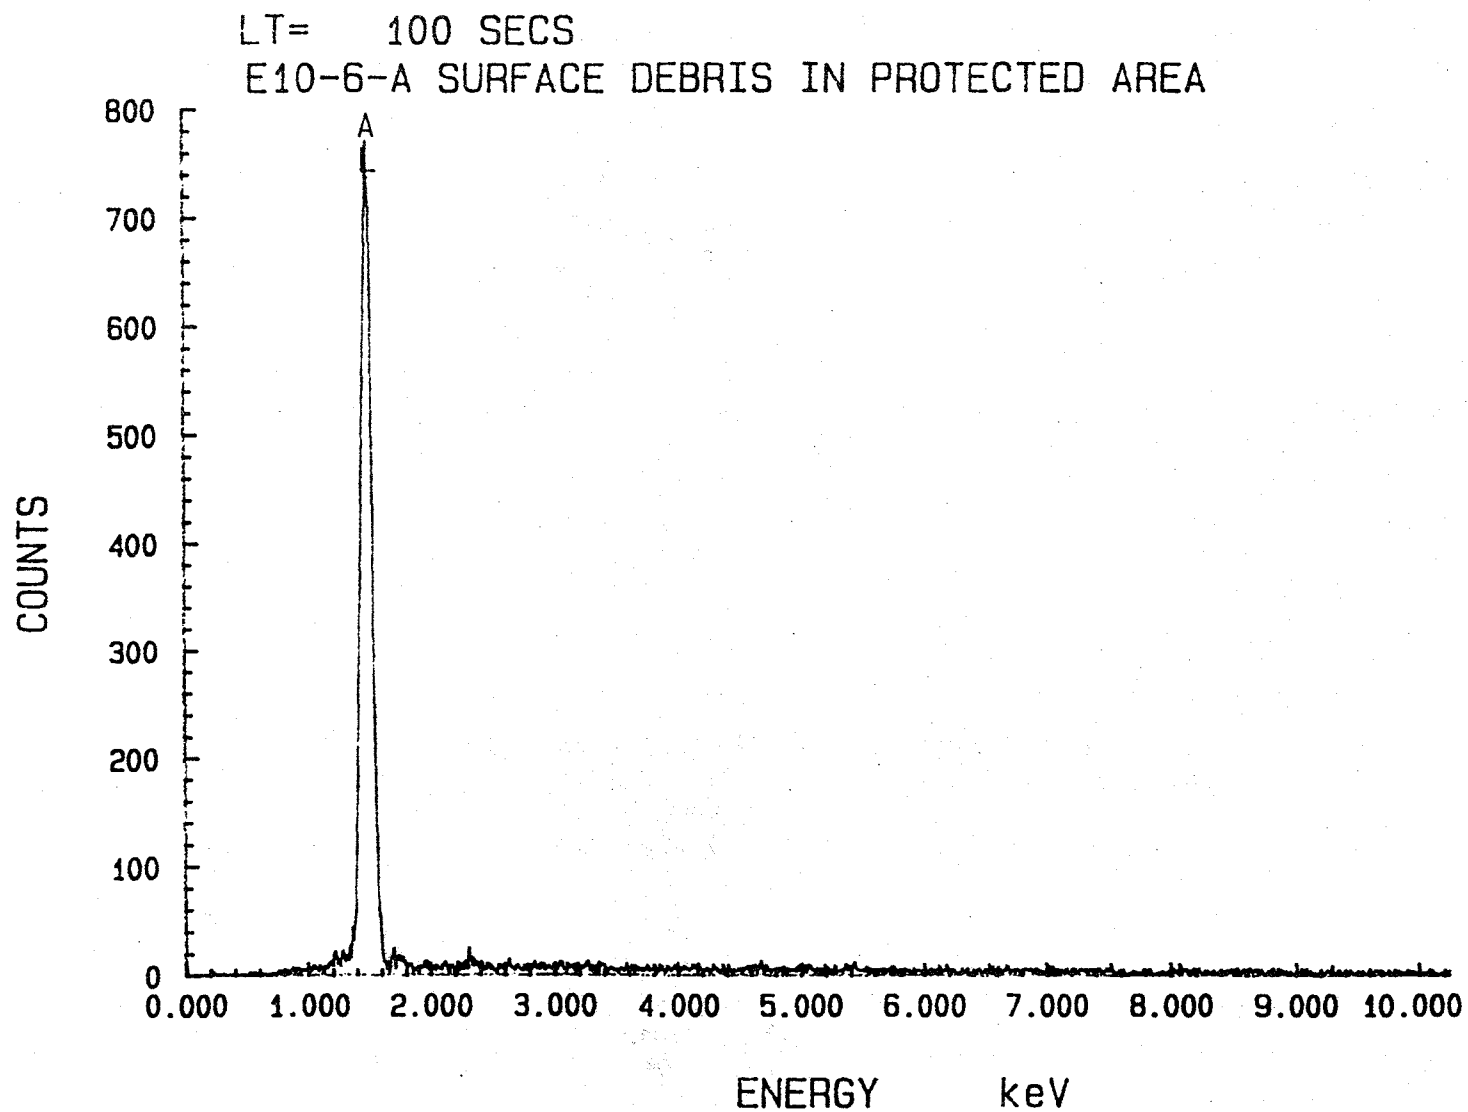
An EDX spectrum obtained from the layer of debris is presented in Figure 8. The data indicates that the material was comprised solely of aluminum, probably in the form of aluminum oxide. The exact source of this layer is not known at the present time. However, it is probably related to some smearing of the surface associated with the application of the anodize coating. Regardless of the source, Figure 6 indicates that it is absent from the areas of the clamp that were exposed to the space environment. This indicates that oxidation of the surface has occurred as a result of exposure.

FIGURE 8. EDX elemental spectrum of surface layer observed on protected surface of tray clamp E10-6

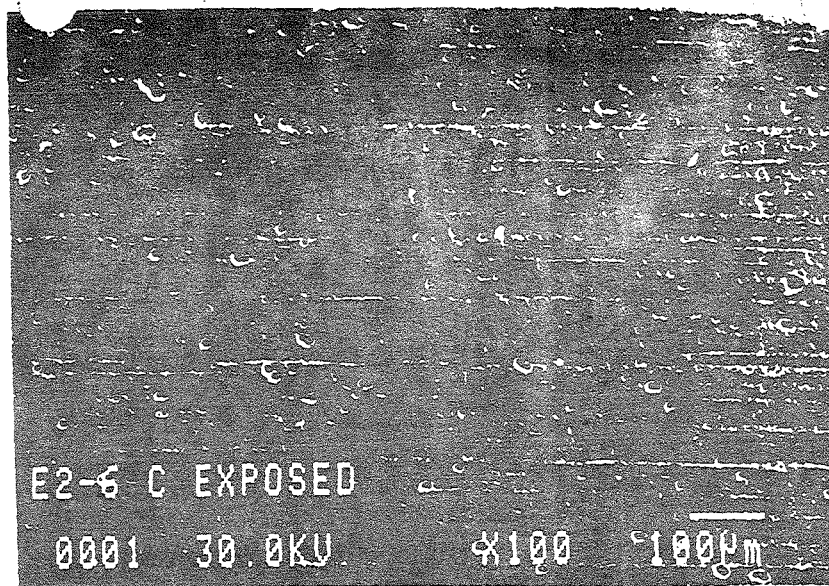
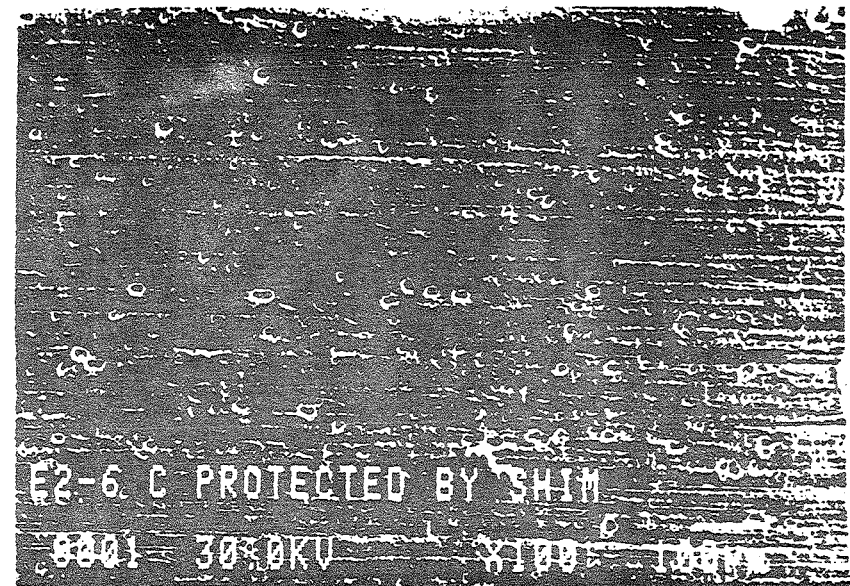
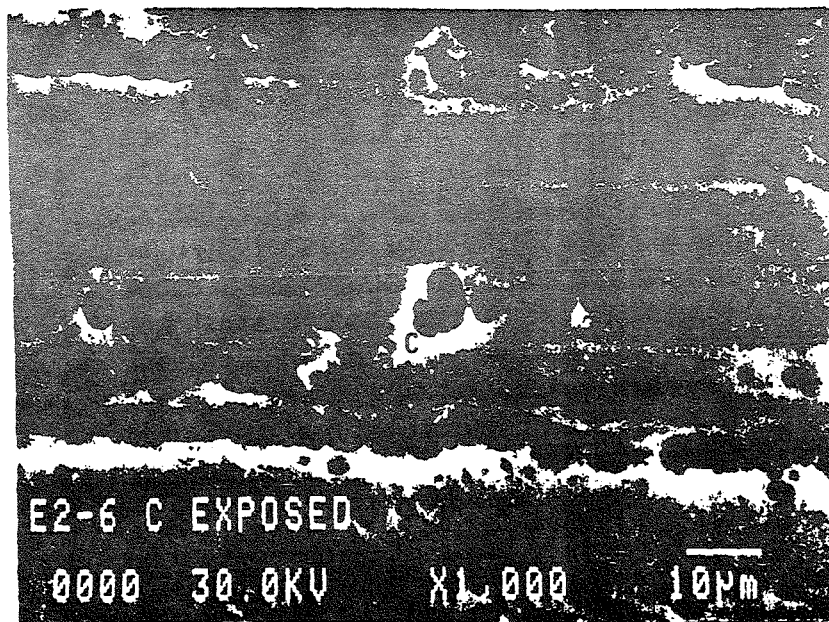
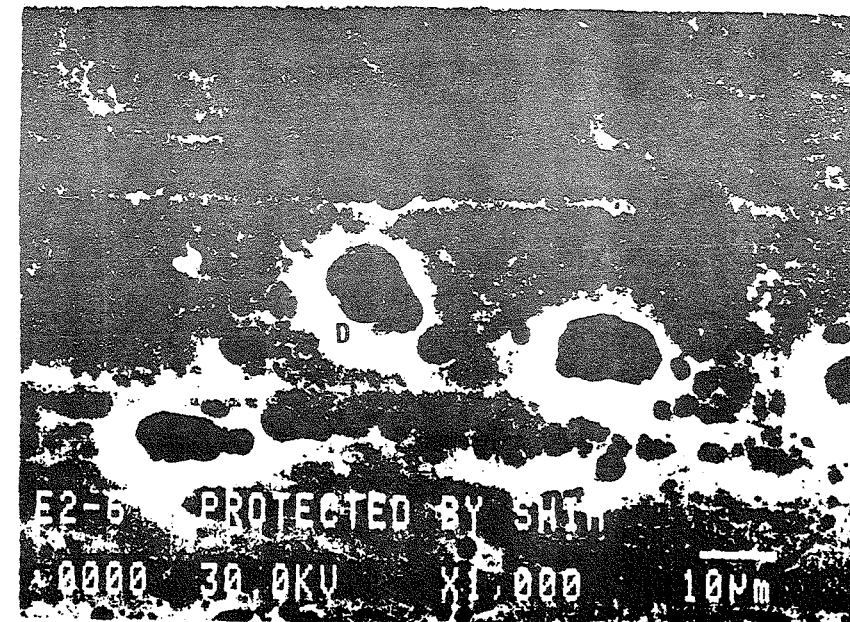
Figure 9 contains SEM photomicrographs of both exposed (Figure 9 A&C) and protected (Figure 9 B&D) areas from the surface of a trailing edge clamp, E-02-6. As seen in these figures the surface of the clamp appears to be moderately pitted and there is no significant variation in the amount of pitting present on the exposed or protected surface.

FIGURE 9. SEM photomicrographs depicting surface porosity on (A) exposed and (B) protected at 100X and (C) exposed and (D) protected at 1000X for trailing edge clamp E02-6. 183

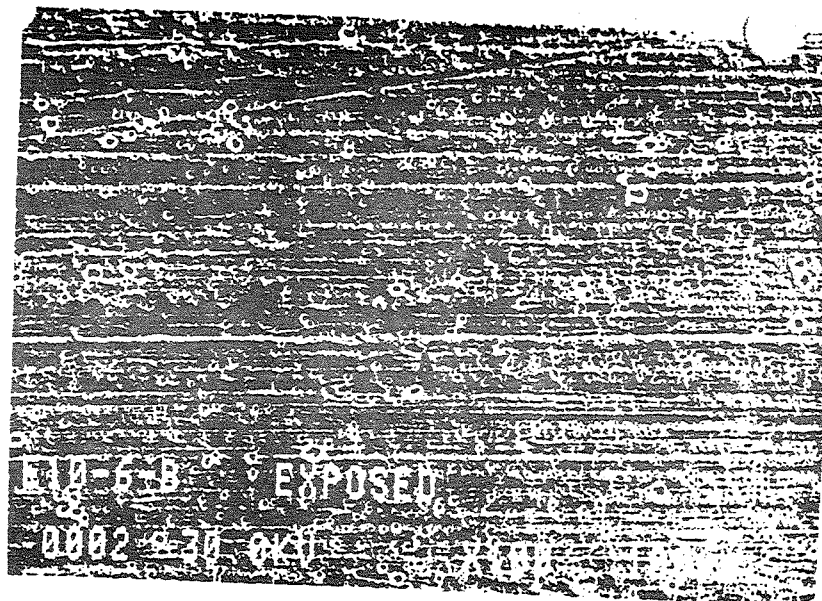
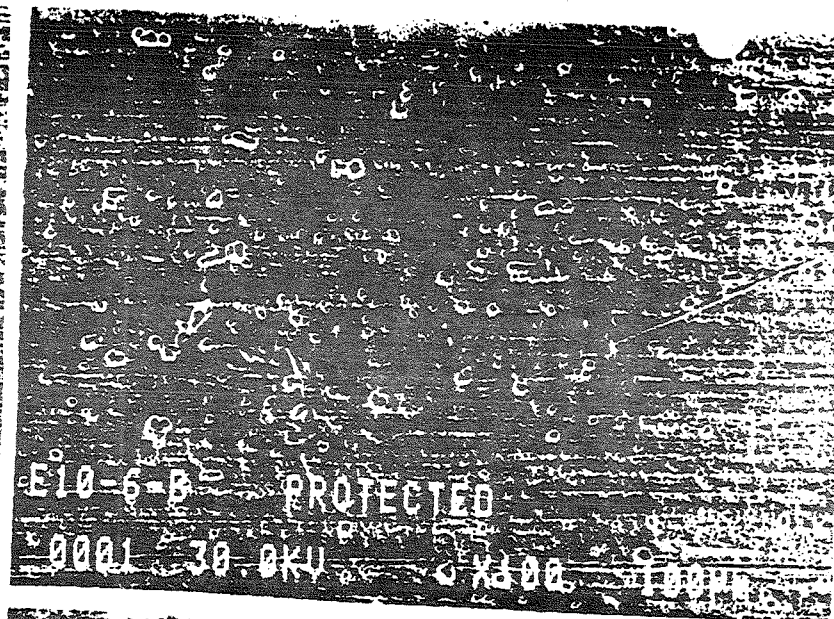
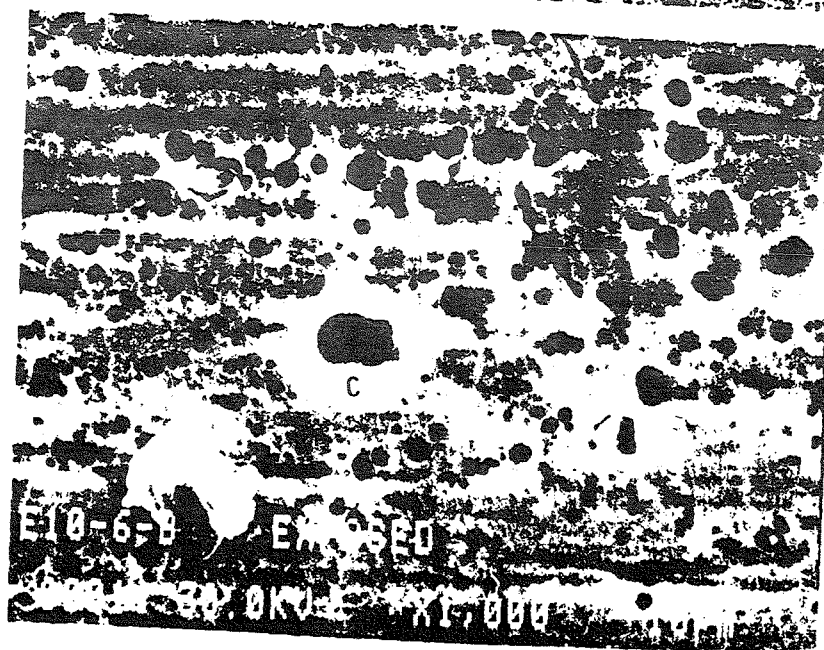
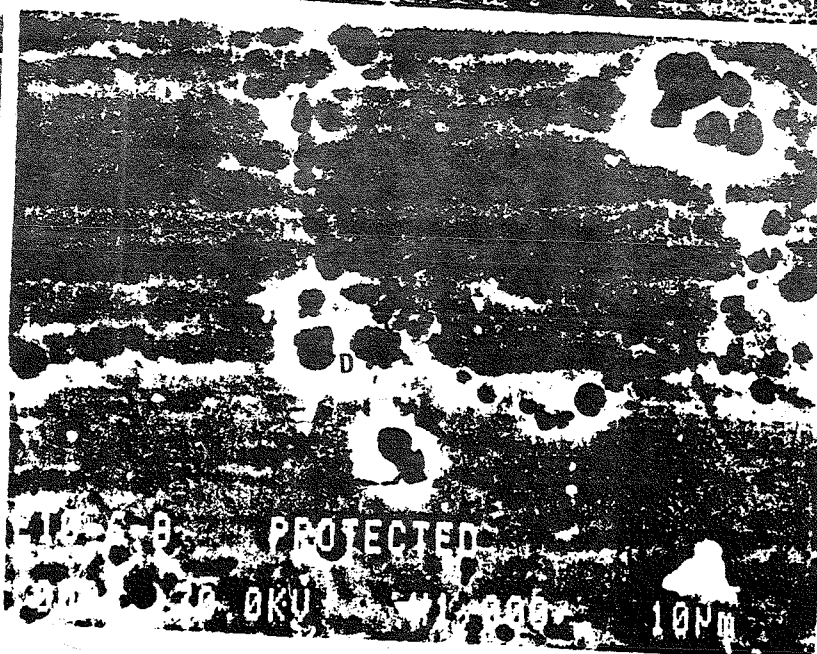
Figure 10 contains SEM photomicrographs of exposed (Figure 10 A&C) and protected (Figure 10 B&D) areas from a leading edge tray clamp, E-10-6. It should be noted that, while pits are also present in both the exposed and protected areas of the coating, the number of pits present on the exposed surface in this case is considerably greater than on the protected surface. Since the pits were observed on both the exposed and protected areas of the surface, coupled with the fact that their morphology was similar in both areas it has been concluded that their presence was probably the result of coating degradation as opposed to micrometeorite damage. The data obtained during the current analysis indicates therefore that leading edge exposure may degrade the anodize coating. Further testing in this area is needed, however. More clamps need to be analyzed to confirm these results. The metallurgical analysis should be conducted in conjunction with SIMS profiling to correlate observed degradation with coating thickness. Image analysis should also be employed to quantify the degree of pitting.

FIGURE 10. SEM photomicrographs depicting surface porosity on (A) exposed and (B) protected at 100X and (C) exposed and (D) protected at 1000X for leading edge clamp E10-6.
